Heatherden Hall, Pinewood Studios, Pinewood Road, Iver Heath, Buckinghamshire, SL0 0NH

Discharge of Condition 2 (Planning Ref: PL/23/3928/HB)

August 21st 2024

Appendix 2 – Material Analysis Report by Heritage Testing Ltd.

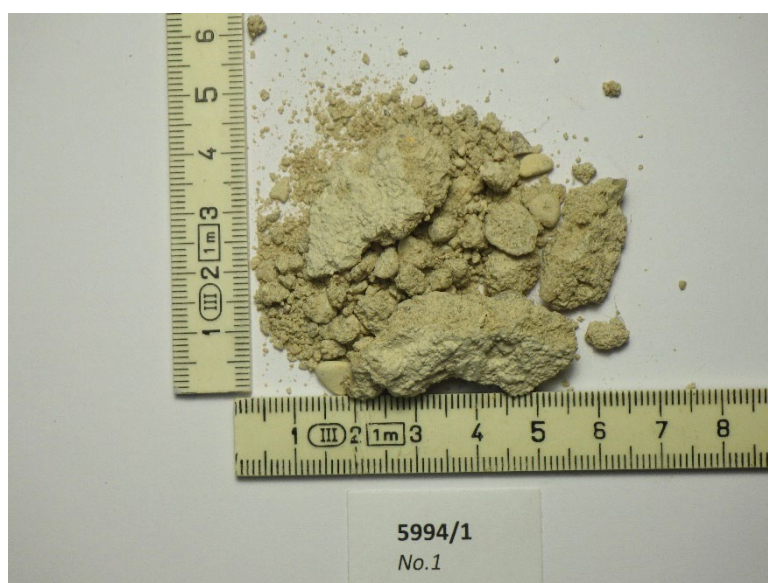
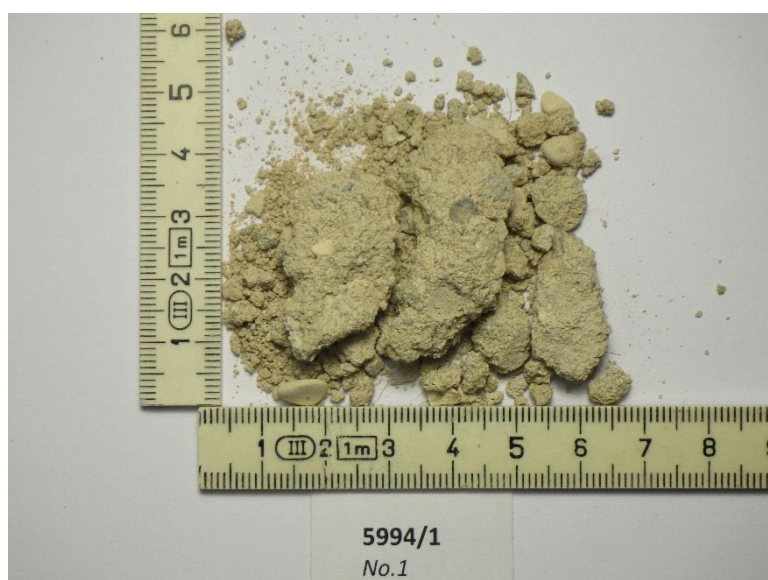
Figs 1 to 2: Sample 5994/1: Photographs of plaster sample received for test (dry condition).

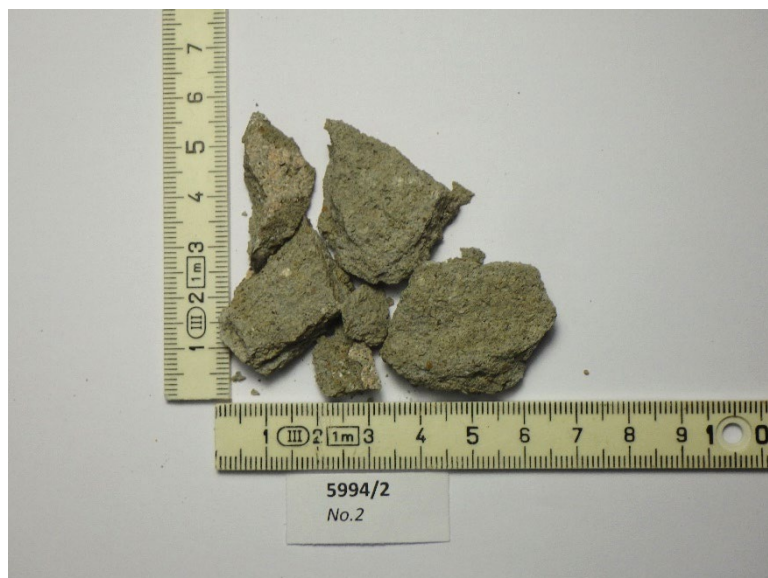
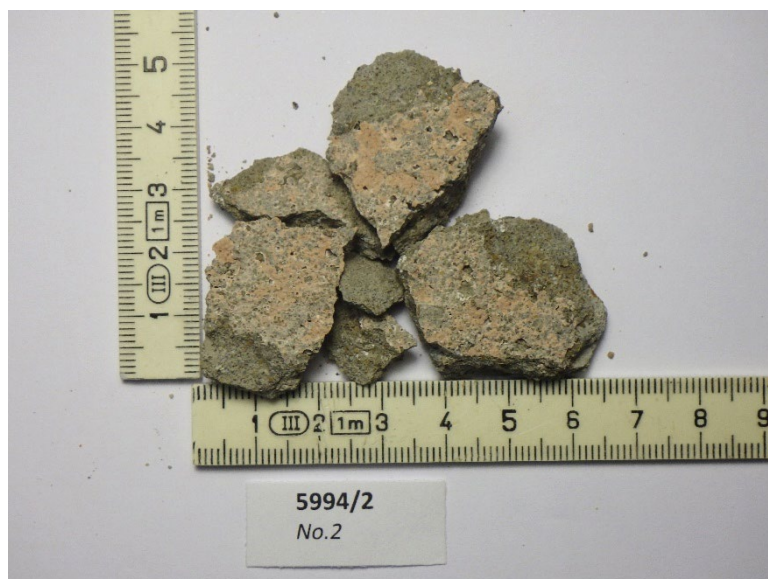
Figs 3 to 4: Sample 5994/2: Photographs of plaster sample received for test (dry condition).

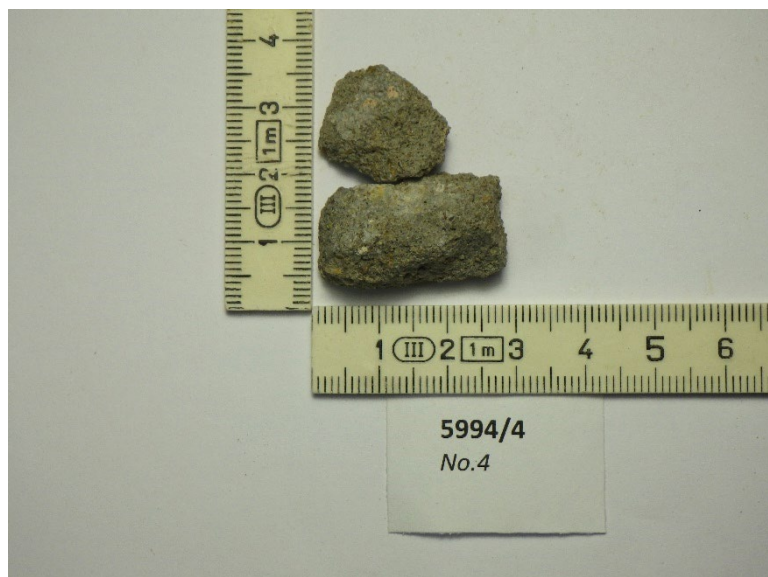
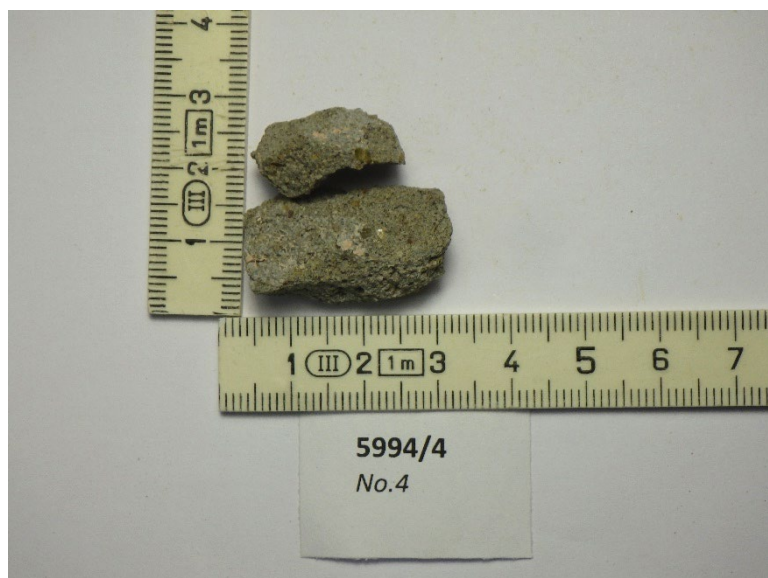
Figs 7 to 8: Sample 5994/4: Photographs of plaster sample received for test (dry condition).

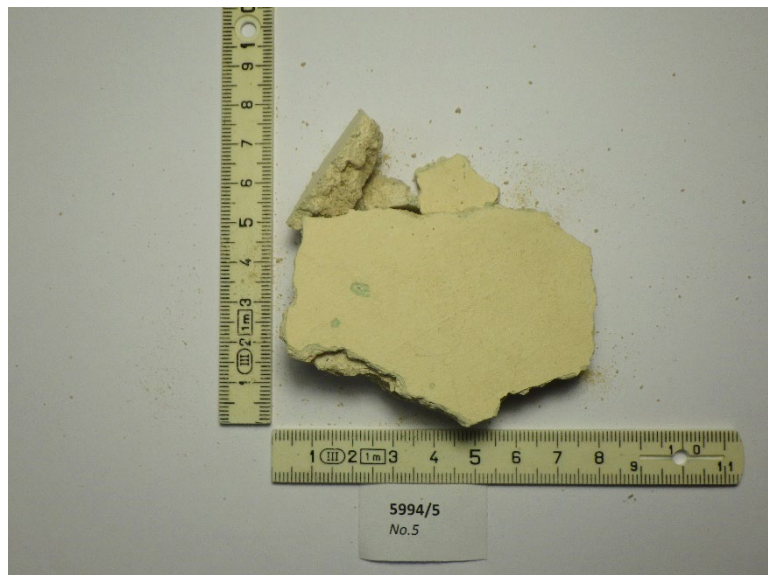
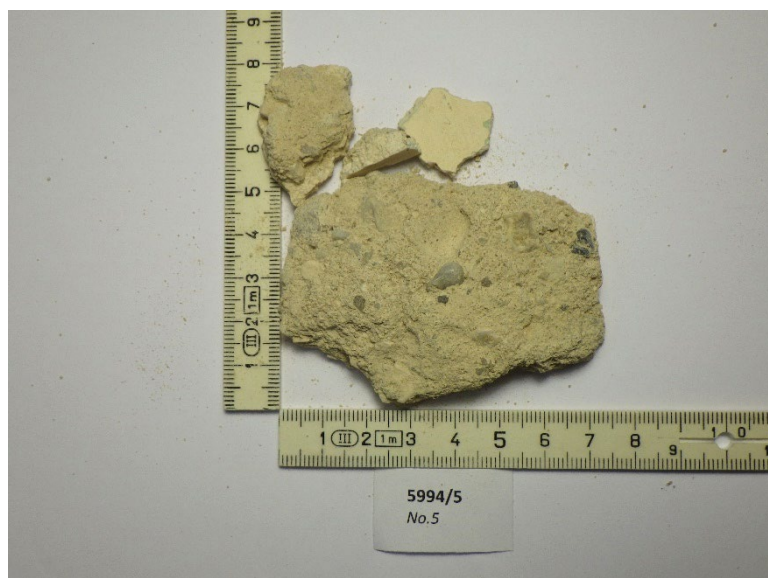
Figs 9 to 10: Sample 5994/5: Photographs of plaster sample received for test (dry condition).

- 9.11) The paint system associated with plaster sample **5994/3** ('Sample 3') was found to contain very high lead levels, whilst that associated with plaster sample **5994/5** ('Sample 5') contained moderately high levels of lead and significant levels of chromium (probably associated with the green undercoat).

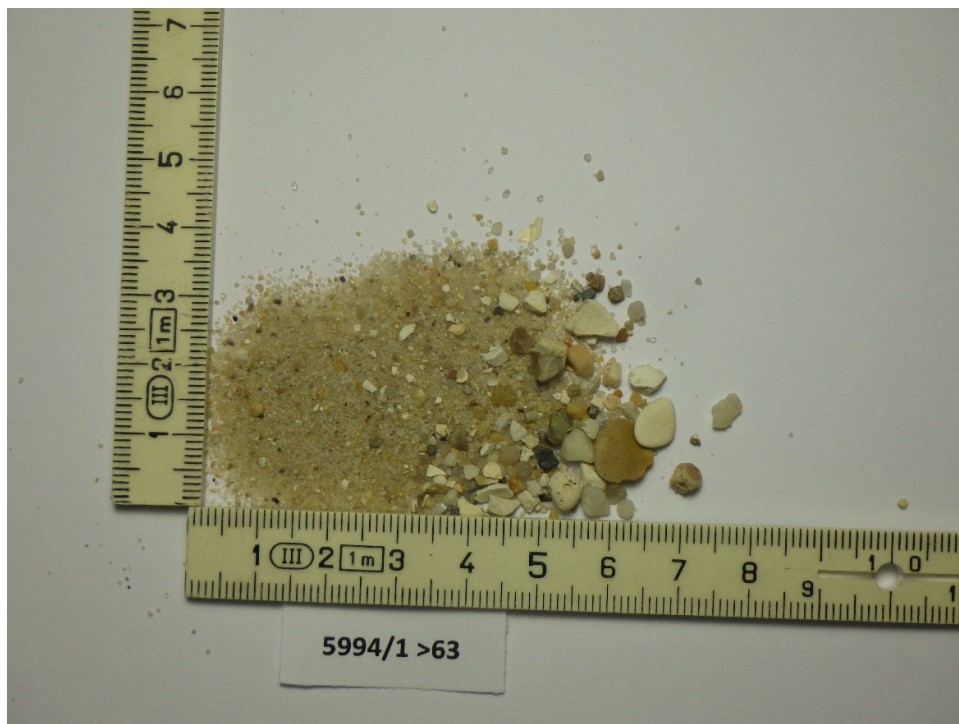
REF 5994/1: SAMPLE 1: SECOND LEVEL, ROOM 58 - INTERNAL PLASTER

Figs 11 to 13: Plaster sample 5994/1 – Showing respectively:

- **Extracted insoluble sand and aggregate component (dry condition)**
 - **Silt and clay / fines component (dry condition, magnified)**
 - **Hair reinforcement (magnified)**

9.3) Hair reinforcement was noted within ref **5994/1** (sample 1) and the plaster basecoats of refs **5994/3** (sample 3) and **5994/5** (sample 5).

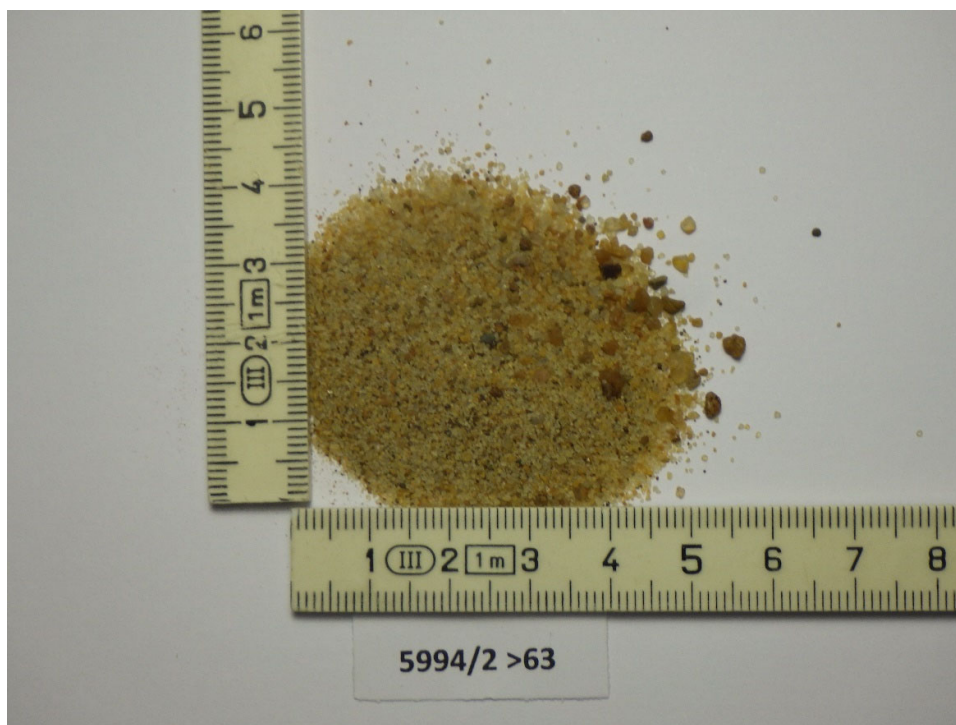
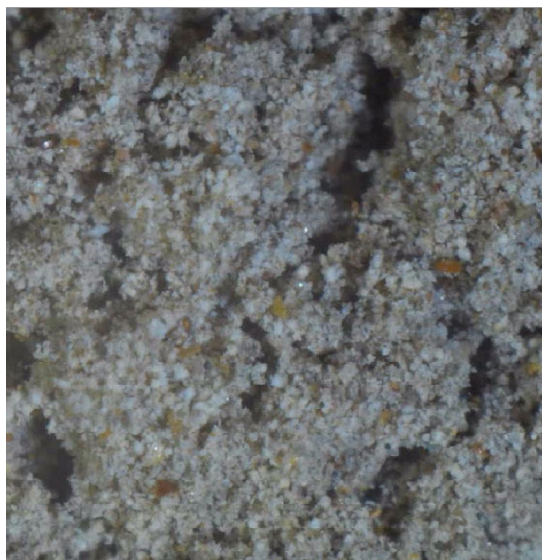
**REF 5994/2: SAMPLE 2: SECOND LEVEL, ROOM 58 - WALL - INTERNAL
PLASTER**

Figs 14 to 15: Plaster sample 5994/2 – Showing respectively:

- **Extracted insoluble sand and aggregate component (dry condition)**
 - **Silt and clay / fines component (dry condition, magnified)**

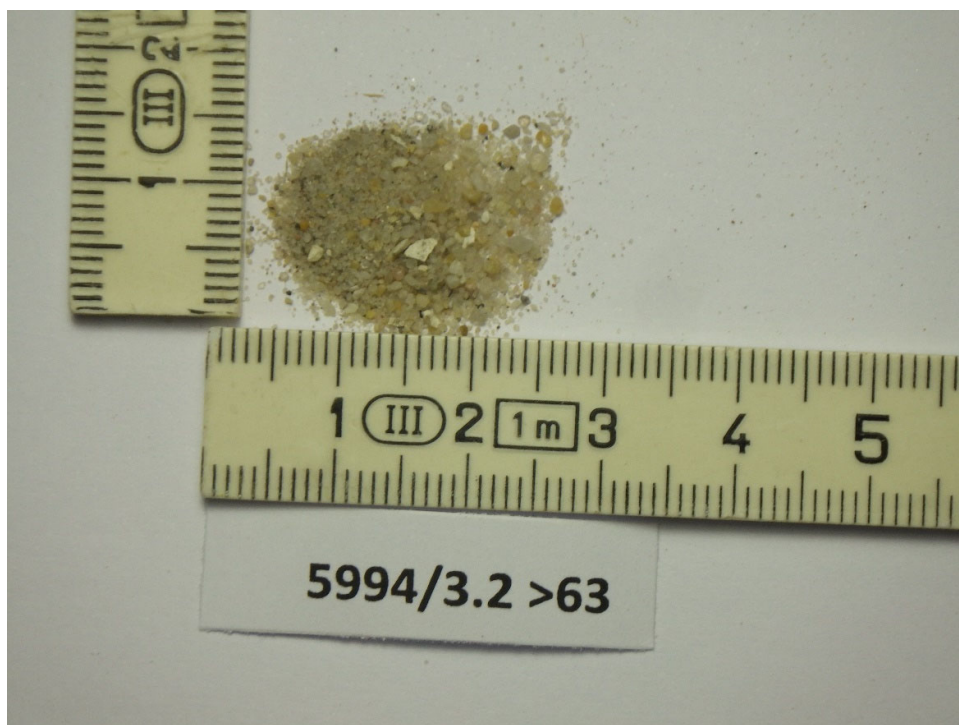
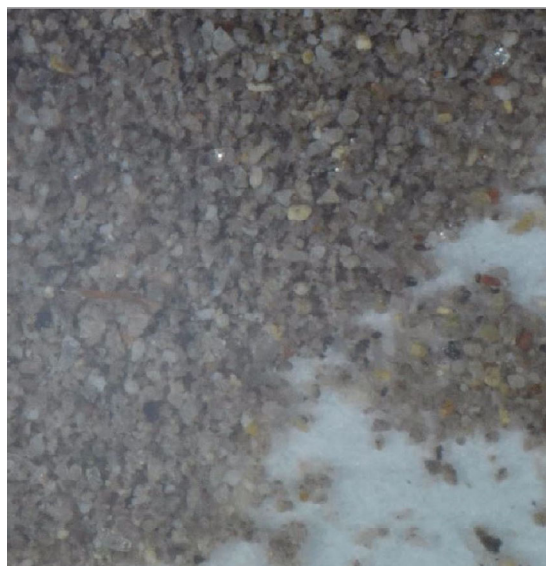
**REF 5994/3.2: SAMPLE 3: SECOND LEVEL, ROOM 65 - WALL - INTERNAL
PLASTER TOPCOAT**

Figs 16 to 17: Plaster topcoat sample 5994/3.2 – Showing respectively:

- Extracted insoluble sand and aggregate component (dry condition)
- Silt and clay / fines component (dry condition, magnified)

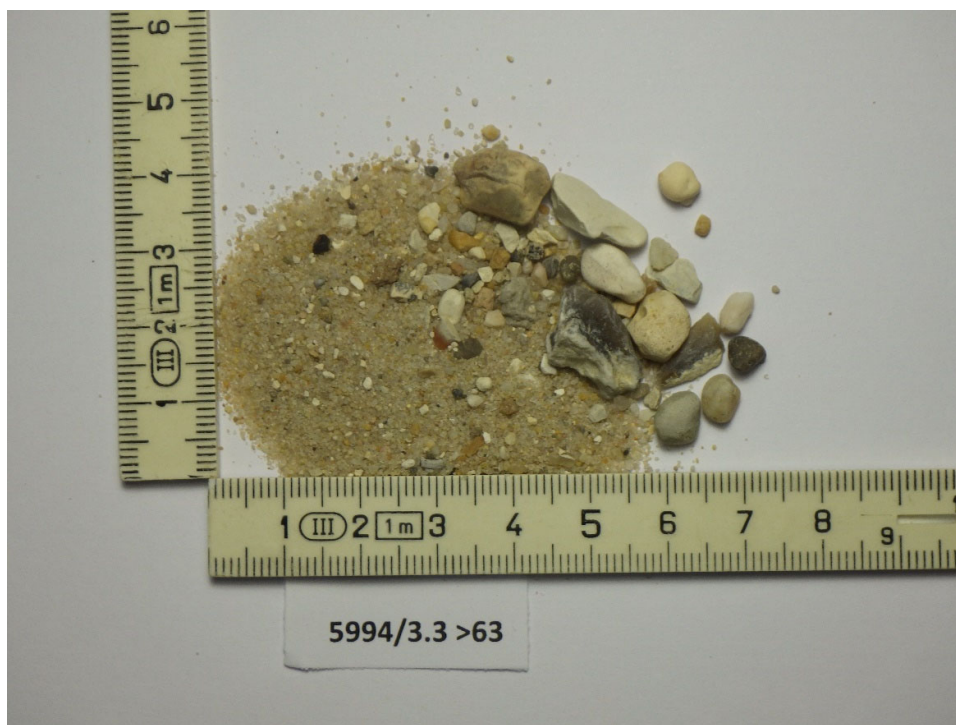
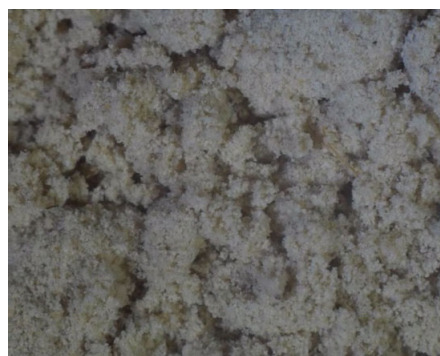
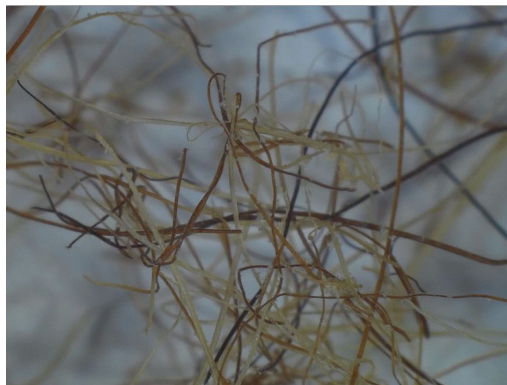
**REF 5994/3.3: SAMPLE 3: SECOND LEVEL, ROOM 65 - WALL - INTERNAL
PLASTER BASECOATS**

Figs 18 to 20: Plaster basecoat sample 5994/3.3 – Showing respectively:

- **Extracted insoluble sand and aggregate component (dry condition)**
 - **Silt and clay / fines component (dry condition, magnified)**
 - **Hair reinforcement (magnified)**

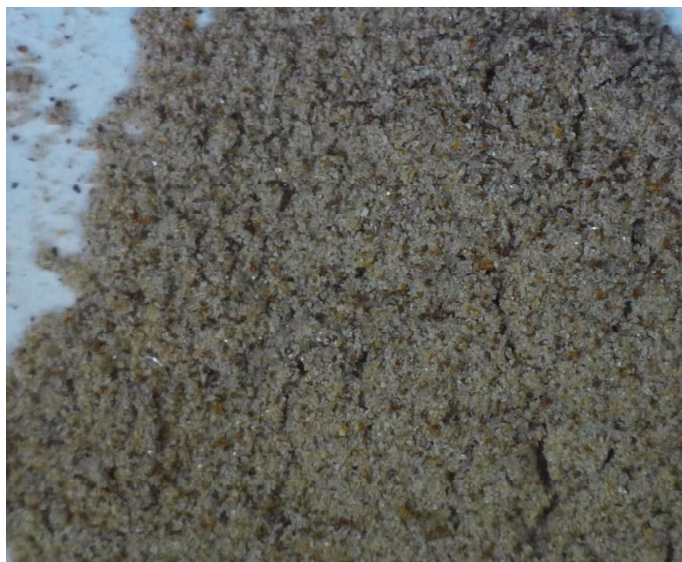
**REF 5994/4: SAMPLE 4: SECOND LEVEL, ROOM 63 - WALL - INTERNAL
PLASTER**

Figs 21 to 22: Plaster sample 5994/4 – Showing respectively:

- **Extracted insoluble sand and aggregate component (dry condition)**
 - **Silt and clay / fines component (dry condition, magnified)**

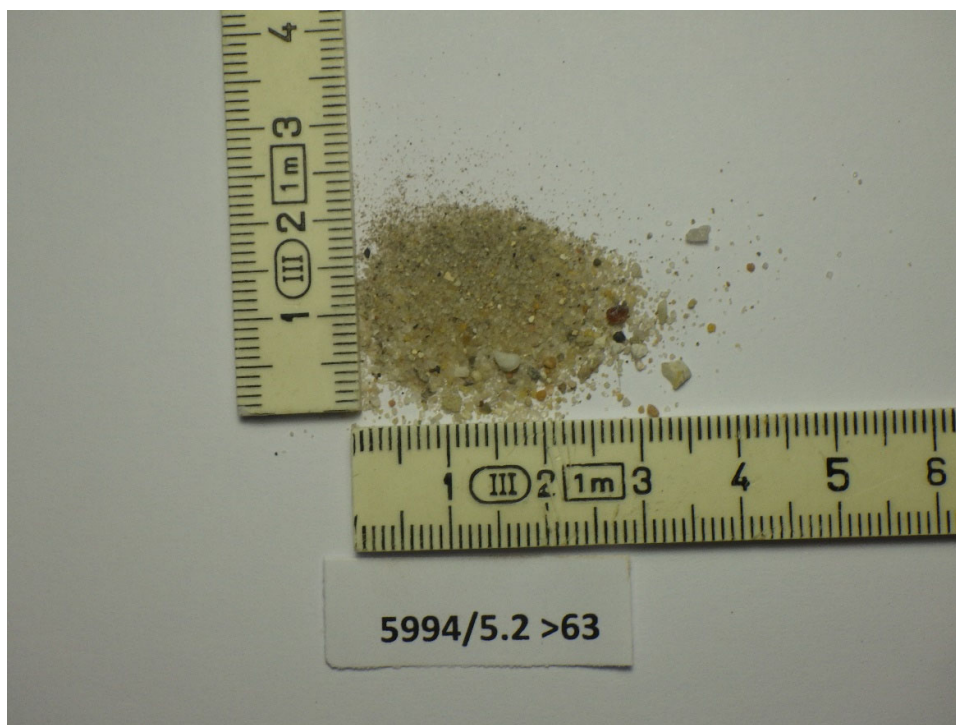
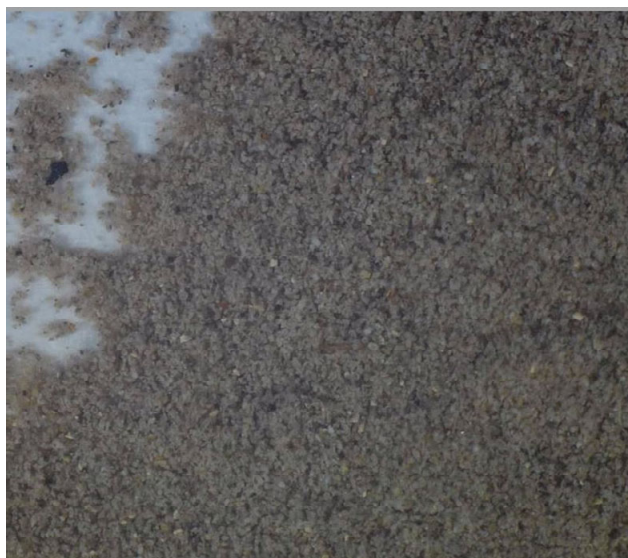
**REF 5994/5.2: SAMPLE 5: SECOND LEVEL, AREA R12 - WALL BELOW
WINDOW - INTERNAL PLASTER TOPCOAT**

Figs 23 to 24: Plaster topcoat sample 5994/5.2 – Showing respectively:

- **Extracted insoluble sand and aggregate component (dry condition)**
- **Silt and clay / fines component (dry condition, magnified)**

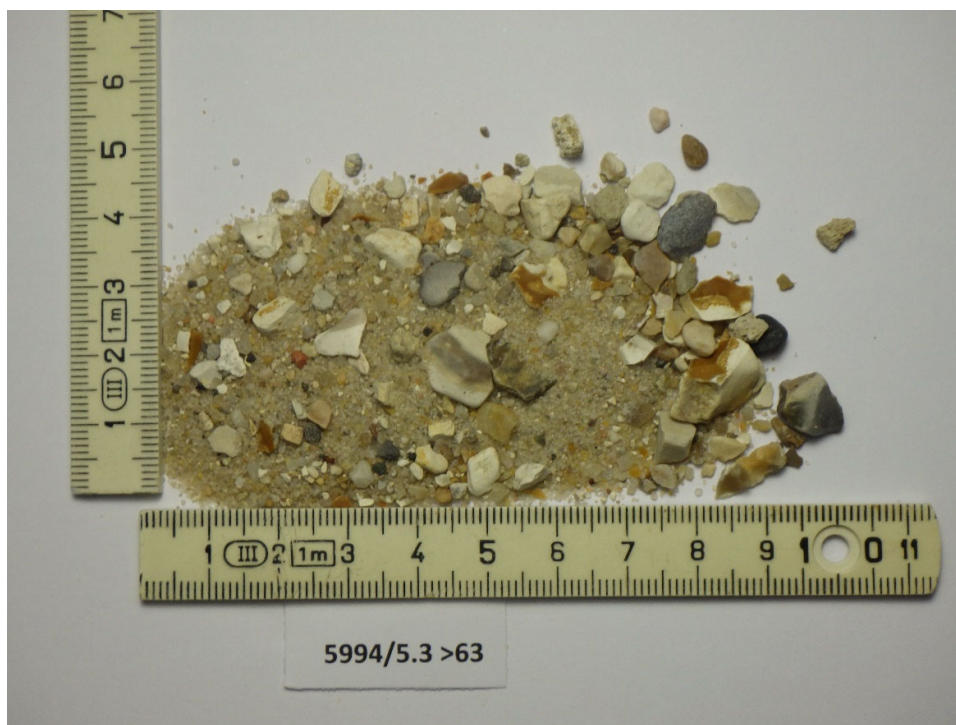
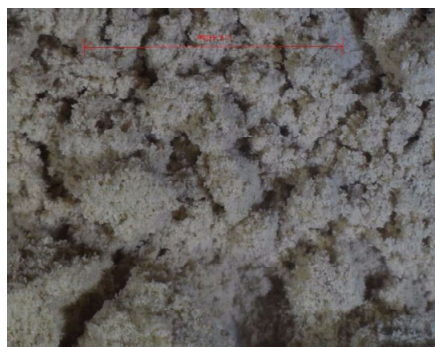
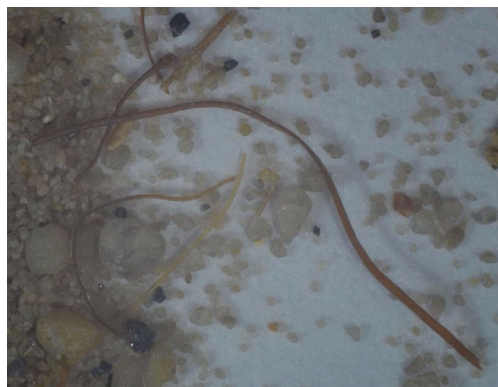
**REF 5994/5.3: SAMPLE 5: SECOND LEVEL, AREA R12 - WALL BELOW
WINDOW - INTERNAL PLASTER BASECOATS**

Figs 25 to 27: Plaster basecoat sample 5994/5.3 – Showing respectively:

- **Extracted insoluble sand and aggregate component (dry condition)**
 - **Silt and clay / fines component (dry condition, magnified)**
 - **Hair reinforcement (magnified)**

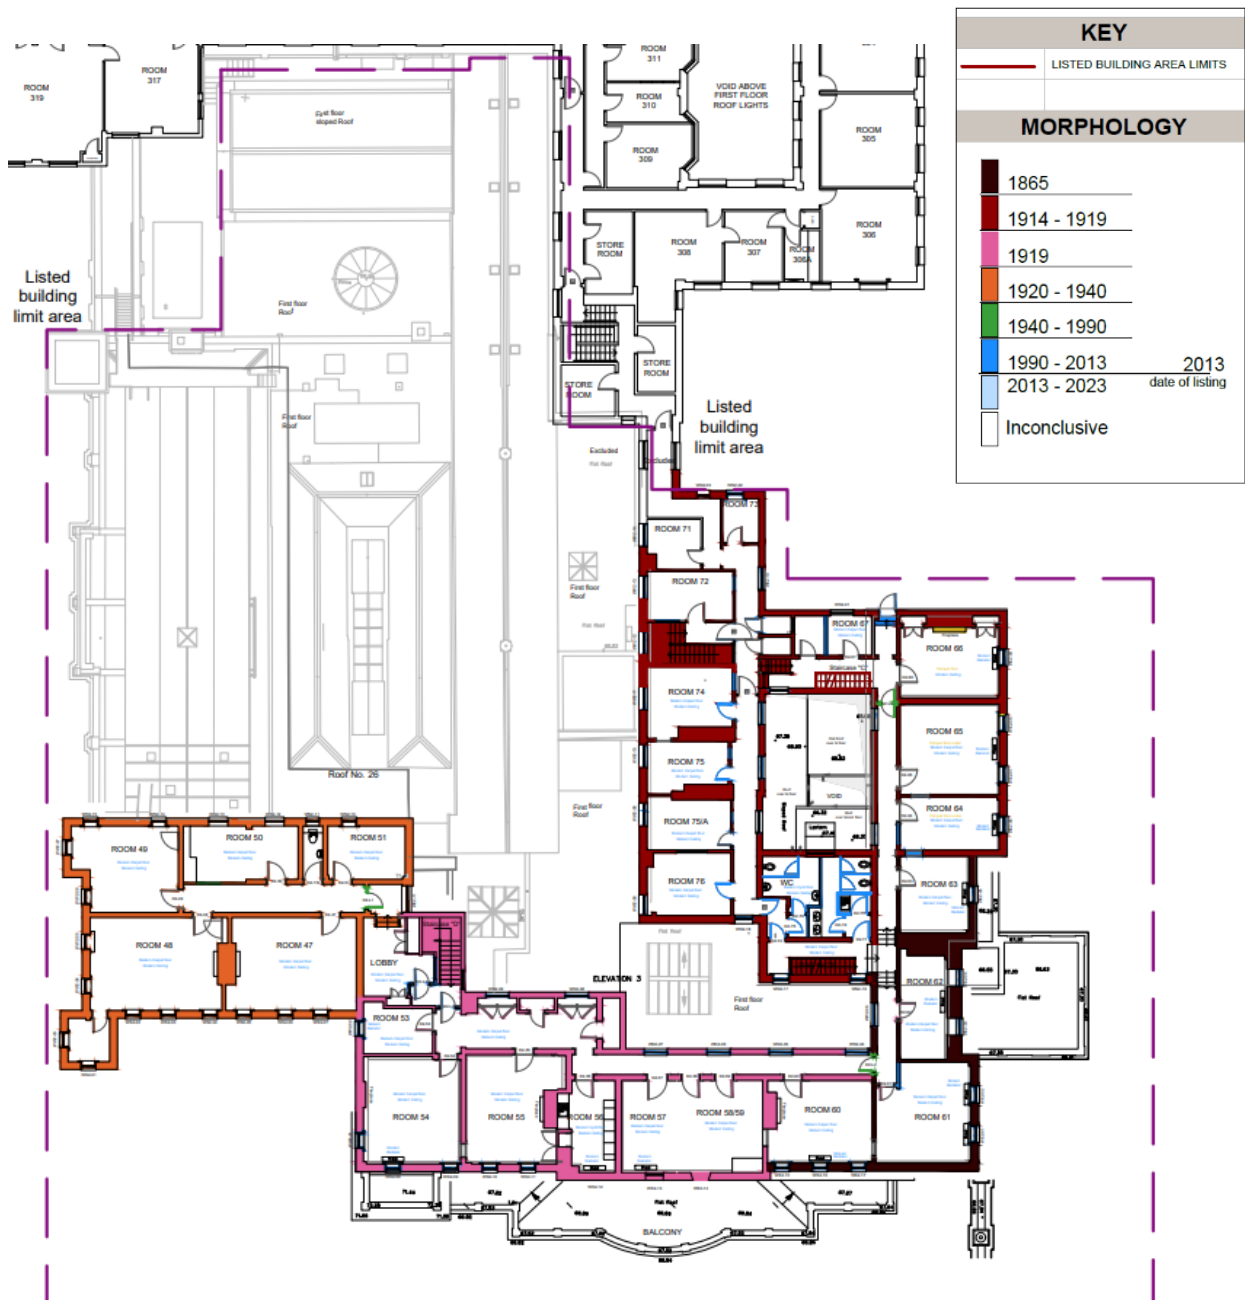
Appendix 4 – Morphological Plan (Level 2)

7. These results are not surprising given that:
 1. From historic archival research, we know that the building underwent various phases, and the internal layout of the second floor dates to the first half of the 20th century, as indicated in the morphological plan (Appendix 4).
